**Flood Control Project Maintenance
Levee Inspections****LMA District Cover Sheet****Spring 2014 Levee Inspection Results****Reclamation District No. 2068 Yolano**

Levee Inspection Report By Mile - Spring 2014

Reclamation District No. 2068 Yolano

Waterway	Bank	Unit Miles	Inspection Start/End	Inspector
Unit No. 01 Yolo Bypass	Right	5.50	04/11/2014 04/11/2014	Herman Phillips

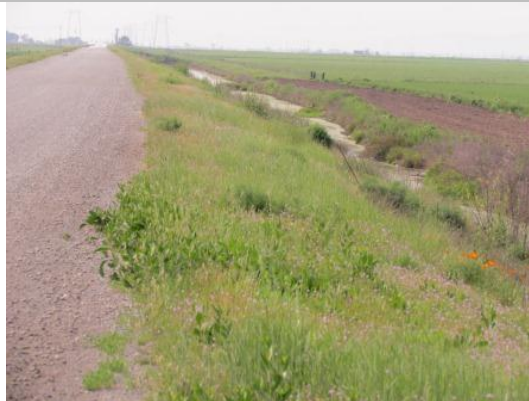
Photo 1 of 1 : phillips_s_20140421_789.jpg

LM Start	0.49	Rating **	M	Issue No.	1
LM End	2.51	Issue Type +	En	Location *	LS
Category	Earthen Levee			GPS Latitude/Longitude	
				Start	End
Item	Encroachments			38.401308 °	38.372530 °
				-121.693788 °	-121.693775 °
DWR ID	DWR_RD2068_01_s _ 2012_1				
Action/Comments					
Ditch Inspector Comments: The Reclamation District has a drainage ditch along the toe of the landward slope. Levee mile 0.49-2.50. This drainage ditch has always been at this location.

District drain ditch. Photo taken 4-11-2014.

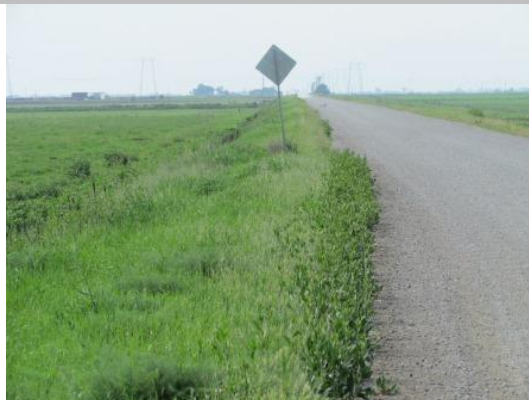
Photo 1 of 1 : phillips_s_20140421_788.jpg

LM Start	0.52	Rating **	M	Issue No.	168
LM End	0.52	Issue Type +	Ma	Location *	WS
Category	Earthen Levee			GPS Latitude/Longitude	
				Start	End
Item	Vegetation			38.401123 °	38.401123 °
				-121.693832 °	°
DWR ID	DWR_RD2068_01_s _ 2014_168				
Action/Comments					
Control annual grass and weeds on the levee slopes and easements.

Looking downstream from Levee mile 0.52 watersides slop. Photo taken 4-11-2014.

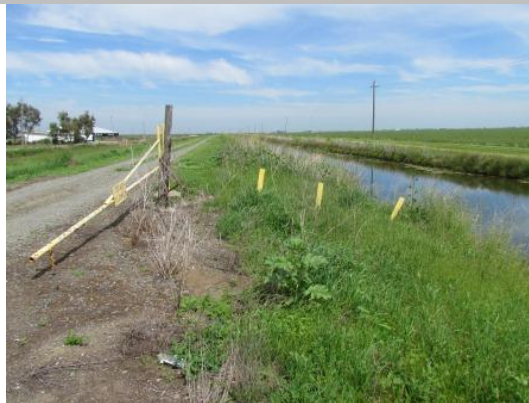
Photo 1 of 1 : phillips_s_20140421_791.jpg

LM Start	0.01	Rating **	M	Issue No.	66
LM End	0.93	Issue Type +	Ma	Location *	WS
Category	Earthen Levee			GPS Latitude/Longitude	
				Start	End
Item	Vegetation			38.358449 °	38.371615 °
				-121.740390 °	-121.740067 °
DWR ID	DWR_RD2068_02_s _ 2014_66				
Action/Comments					
Control annual grass and weeds on the levee slopes and easements.

This photo shows the waterside of unit 2 looking downstream, tall weeds exist on the levee slope. Photo taken 4-11-2014.

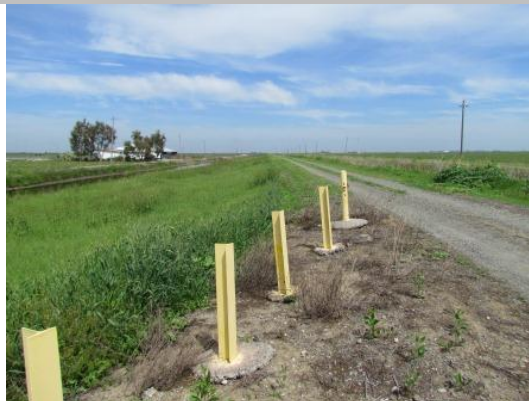
Photo 1 of 1 : phillips_s_20140421_790.jpg

LM Start	0.01	Rating **	M	Issue No.	65
LM End	0.93	Issue Type +	Ma	Location *	LS
Category	Earthen Levee			GPS Latitude/Longitude	
				Start	End
Item	Vegetation			38.358451 °	38.371616 °
				-121.740398 °	-121.740067 °
DWR ID	DWR_RD2068_02_s _ 2014_65				
Action/Comments					
Control annual grass and weeds on the levee slopes and easements. Inspector Comments: There are tall weeds present on the levee slopes during this inspection, the District had sprayed both slopes just prior to the rain.

Looking downstream from levee mile 0.01 landside slope. Photo taken 4-11-2014.

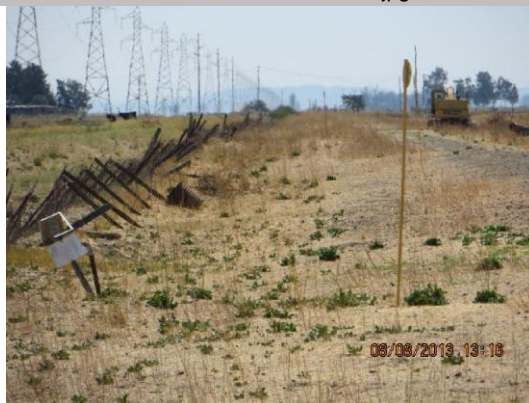
Photo 1 of 1 : UCIP_1609.jpg

LM Start	0.90	Rating **	M	Issue No.	61
LM End	0.90	Issue Type +	En	Location *	LS
Category	Supplemental			GPS Latitude/Longitude	
				Start	End
Item	DWR UCIP Field Study			38.371273 °	38.371273 °
				-121.740138 °	-121.740138 °
DWR ID	DWR_RD2068_02_s _ 2014_61				
Action/Comments					
Inspector Comments: FS_ID:17531					
EP_NO: 8151					
Repair Type:					
Crossing Status:					
UCIP Comments: Appears abandoned. Need to verify with pipeline owner.					
FIELD_STRUCT_DESC: 8-inch steel gas pipe through the levee 3 feet below the crown (Permit No. 8151, 1972). Gasline markers visible on east toe of levee at intersection of levee and Delhi road.					
FS Date: 8/8/2013

Gasline markers next to old rail road grade, looking south.

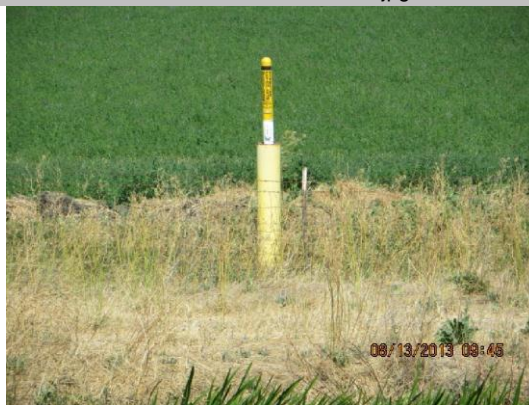
Photo 1 of 1 : UCIP_1611.jpg

LM Start	1.07	Rating **	M	Issue No.	62
LM End	1.07	Issue Type +	En	Location *	LS
Category	Supplemental			GPS Latitude/Longitude	
				Start	End
Item	DWR UCIP Field Study			38.373330 °	38.373330 °
				-121.738530 °	-121.738530 °
DWR ID	DWR_RD2068_02_s _ 2014_62				
Action/Comments					
Inspector Comments: FS_ID:17532					
EP_NO: 13028					
Repair Type:					
Crossing Status:					
UCIP Comments: Need improved signage on LS and WS shoulders.					
FIELD_STRUCT_DESC: 10-inch steel pipe through the levee 2 feet below the crown. A 4-inch gas line is sleeved through the 10-inch pipe.					
Sign missing from marker post on east slope. 2-inch vent pipe with identification sign located off west bank of levee and off toe of east side of levee at fence (Permit No. 13028, 1981).					
FS Date: 8/13/2013

Sign marker off LS toe.

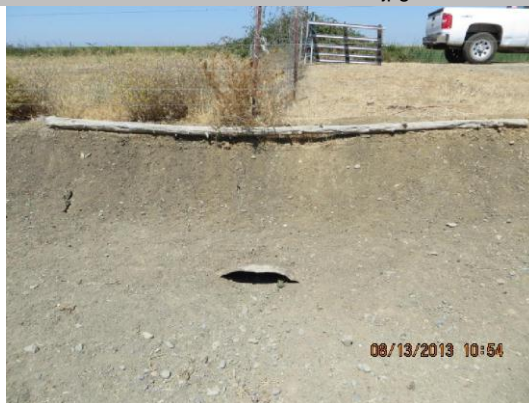
Photo 1 of 1 : UCIP_1613.jpg

LM Start	3.16	Rating **	M	Issue No.	64
LM End	3.16	Issue Type +	En	Location *	LS
Category	Supplemental			GPS Latitude/Longitude	
				Start	End
Item	DWR UCIP Field Study			38.397933 °	38.397933 °
				-121.716406 °	-121.716406 °
DWR ID	DWR_RD2068_02_s _ 2014_64				
Action/Comments					
Inspector Comments: FS_ID:17544					
EP_NO: 10164					
Repair Type:					
Crossing Status:					
UCIP Comments: Appears abandoned and if so should be done properly. Pipe burried except for small opening.					
FIELD_STRUCT_DESC: 6 of 6: 48-inch corrugated metal pipe through the levee 4.0 feet below the crown (ABO No. 10164, 1974). Originally included in the O&M manual, 1962.					
FS Date: 8/13/2013

Pipe buried but visible at toe of east side of levee.
